# CASE STUDY

NEW YORK STATE BEST MANAGEMENT PRACTICES FOR GOLF COURSES

## Wash Load at Bedford Golf and Tennis Club

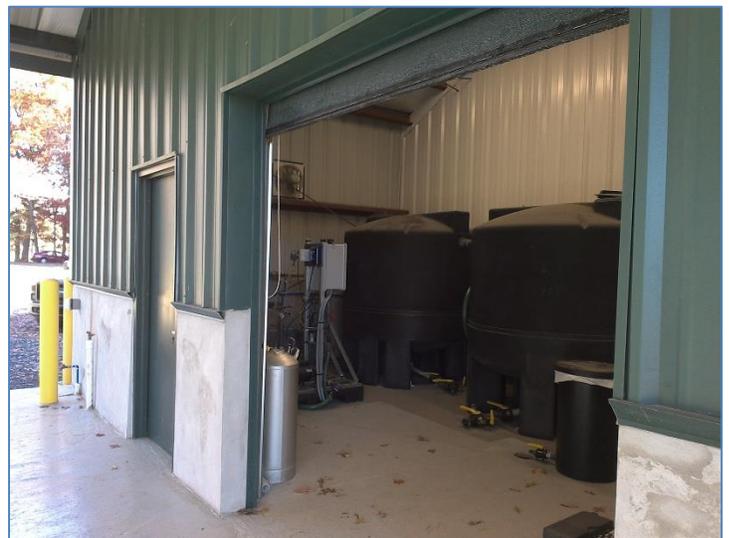
The wash area consists of 4 stations with one central sump. Clippings are blown off the machines in designated areas throughout the course to prevent a large accumulation at the sump. The machines are then washed with continuously recycled water. Two carbon filters filter the water.

Though many systems utilize a drain to daylight in case excess rain water accumulates in the system, the Town of Bedford would not allow this. Therefore, if the system shuts down due to excessive water in the system, it must be pumped through the filters and into an extensive stormwater treatment area adjacent to the building.
